“Safety Boot™” Temporary Railing Base Test

Report Number: 08010055
(6 Pages & 16 Figures)

Report for: Safety First Systems Inc.
7111-F 6th St SE
Calgary, AB, T2H 2M8

Report Date: May 15, 2008

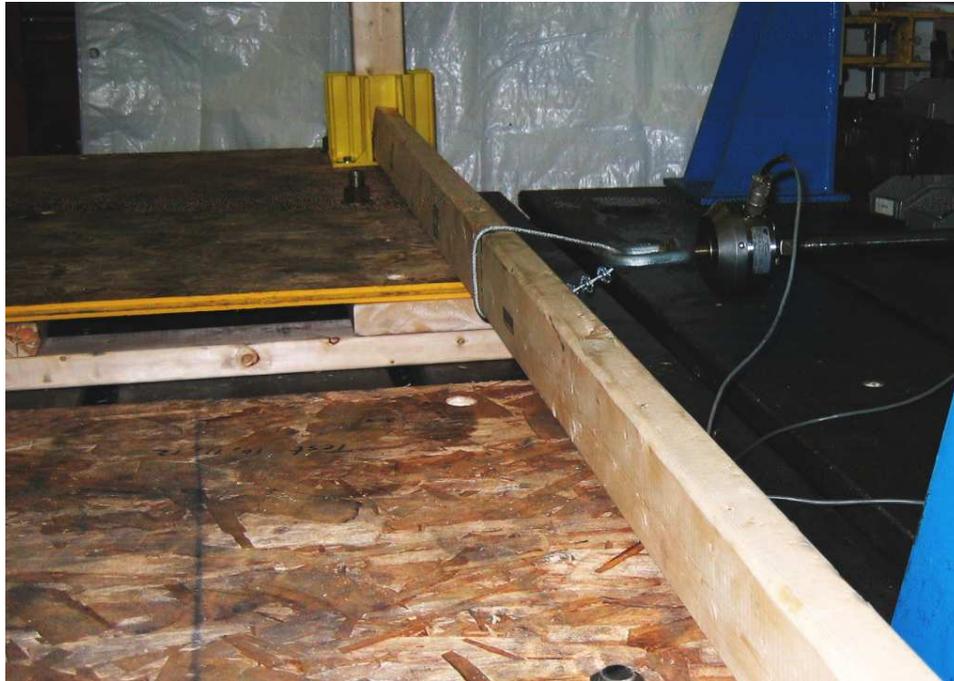
Figure 3: Toe board horizontal load test

Test # 2: Horizontal load test on toe board as shown in Figure 3.

A proof load of 51 lb. was applied at the mid-point of the toe board, in order to evaluate the mid-point strength. The proof load was then increased to 102 lb at the same location. In this case, each end of the toe board was subjected to 51 lb. of force at the same time proving that the toe board was able to withstand 51 lb. horizontal load at any location.

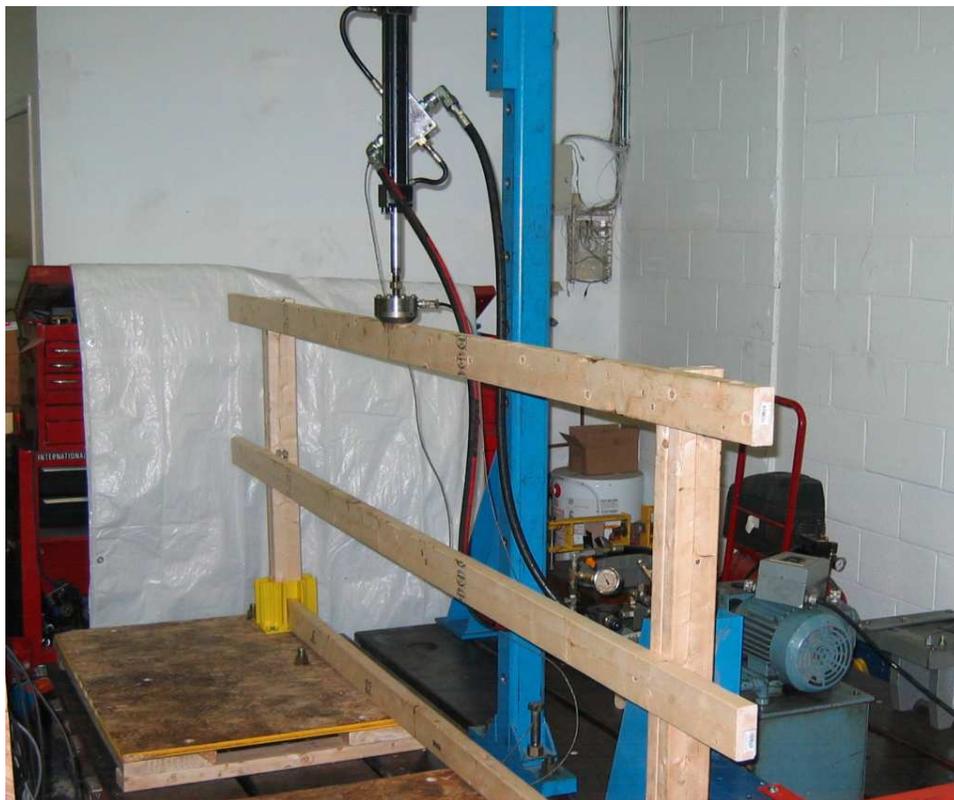
Figure 4: Top rail vertical load test

Test # 3: Vertical load test on top rail at mid-point as shown in Figure 4.

A downward proof load of 101 lb. was applied at the mid-point of the top rail, in order to evaluate the mid-point strength on vertical load. The downward load was then increased to 202 lb. at the same location, in order to distribute two equal 101 lb. at each end of the top rail. Each post was supporting 101 lb of vertical load in this case, proofing that the top rail was able to withstand 101 lb. vertical load at any location.

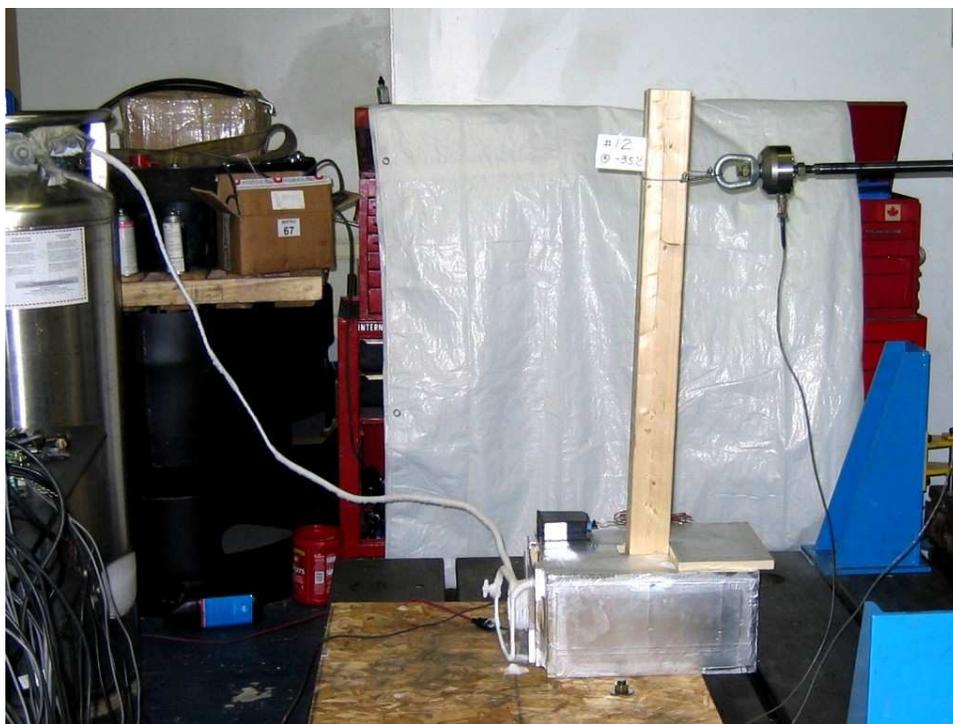
Figure 10: Cold temperature test setup

Four (4) 3/8 x 3 lag screws with 1-1/2 washers were used to fasten the “Safety Boot™” bases through the 23/32 plywood and the 2x10 beam (Figure 9). The sample was then pre-conditioned in a small chamber at specified temperature on the installation for 60 to 90 minutes before the test performed. Part of the floor top surface and the lower portion of the post were also subjected to the test temperature (Figures 10 and 11).

- Test #10 @ -20 °C for 60 minutes prior to test
- Test #11 @ -30 °C for 80 minutes prior to test
- Test #12 @ -35 °C for 90 minutes prior to test

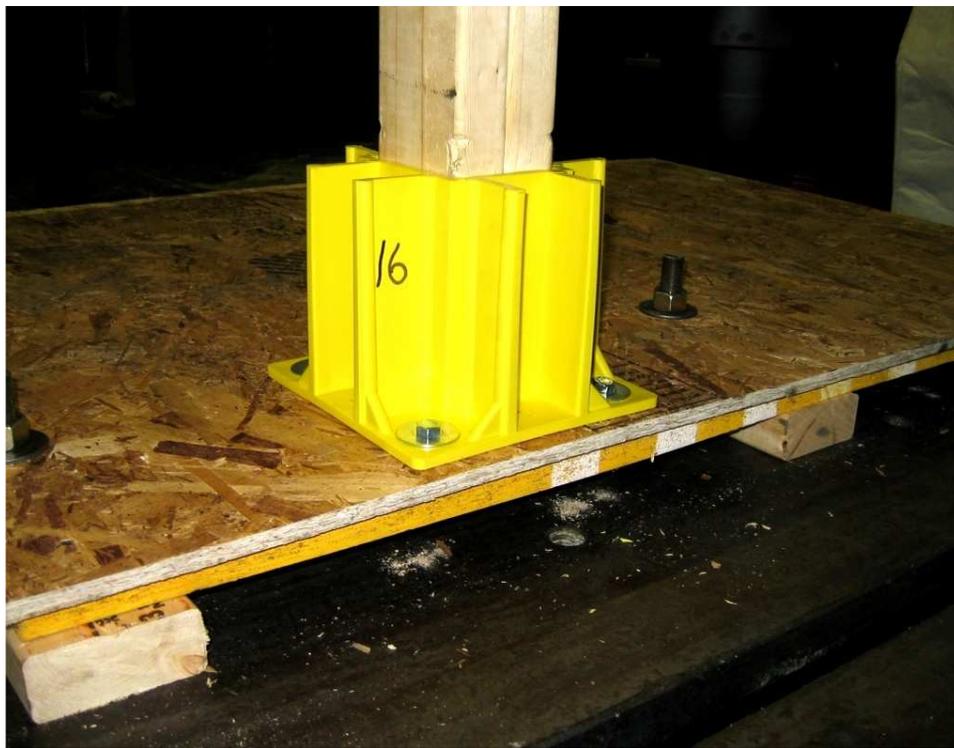
Figure 12: 1-1/8 plywood sub-floor installation

Since the 1-1/8 Surd-I-Floor plywood was not available in Canada, a 6/17 plywood board and a 23/32 plywood board were stacked together to make up a 1-1/8 thickness, as agreed by the client. The boards were fastened together with deck screws to simulate a single piece material. Five (5) 3/8 x 2 lag screws with 1-1/2 washers were used to fasten the “Safety Boot™” bases on the floor material (Figures 12). A 152 lb. proof load test followed by ultimate strength test was performed on each sample.

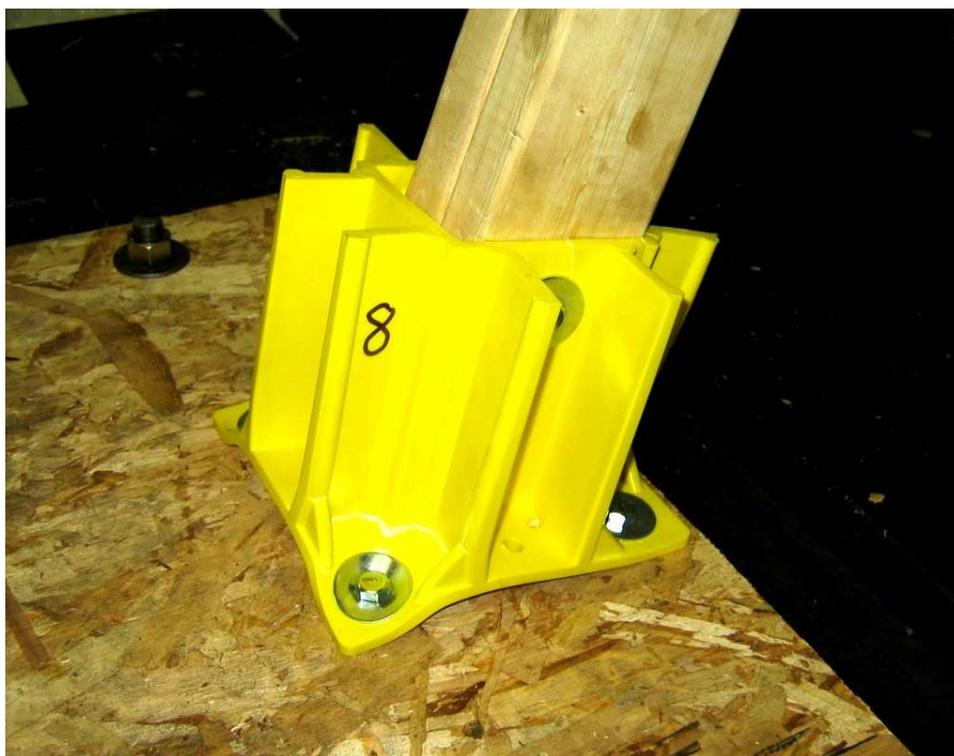
Figure 14: Base deform and crack failures in Test #8

Figures 13 to 16 demonstrate four (4) different types of failures from the tests.

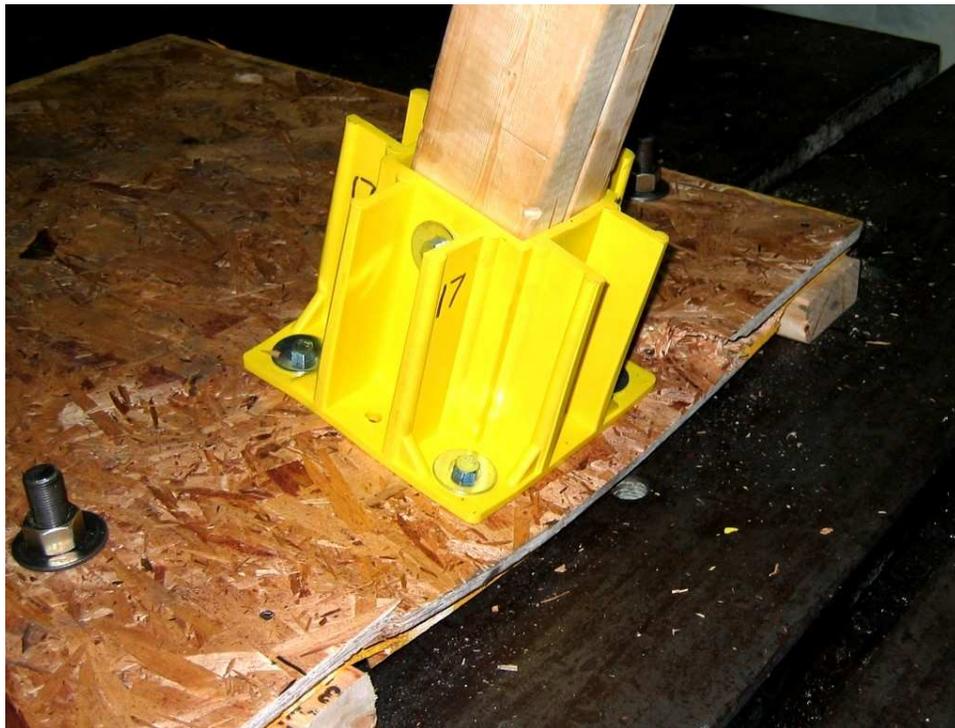
Figure 16: 1-1/8 plywood sub-floor fractured in Test #17
